# USAAVLABS TECHNICAL REPORT 68-9

## T63 REGENERATIVE ENGINE PROGRAM

U. S. ARMY AVIATION MATERIEL LABORATORIES  
FORT EUSTIS, VIRGINIA

CONTRACT DA 44-177-AMC-273(T)  
ALLISON DIVISION - GENERAL MOTORS  
INDIANAPOLIS, INDIANA

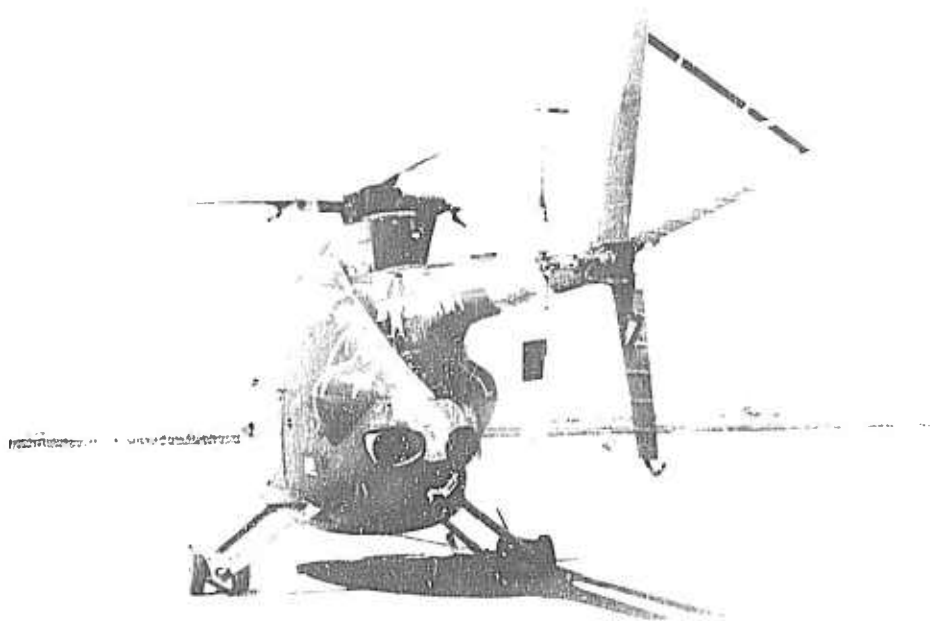
Figure 53. Completed Installation of Regenerative T63 in the YOH-6.

The completed installation is shown in Figures 53 through 56. A weight and balance check obtained after completion of the fabrication is as follows:

Originally the exhaust extensions were scarfed as shown in Figure 53. To prevent the possibility of exhaust gas flow into the compartment, an 8-in.-diameter pipe was installed over the extensions. The pipe extended 3 in.

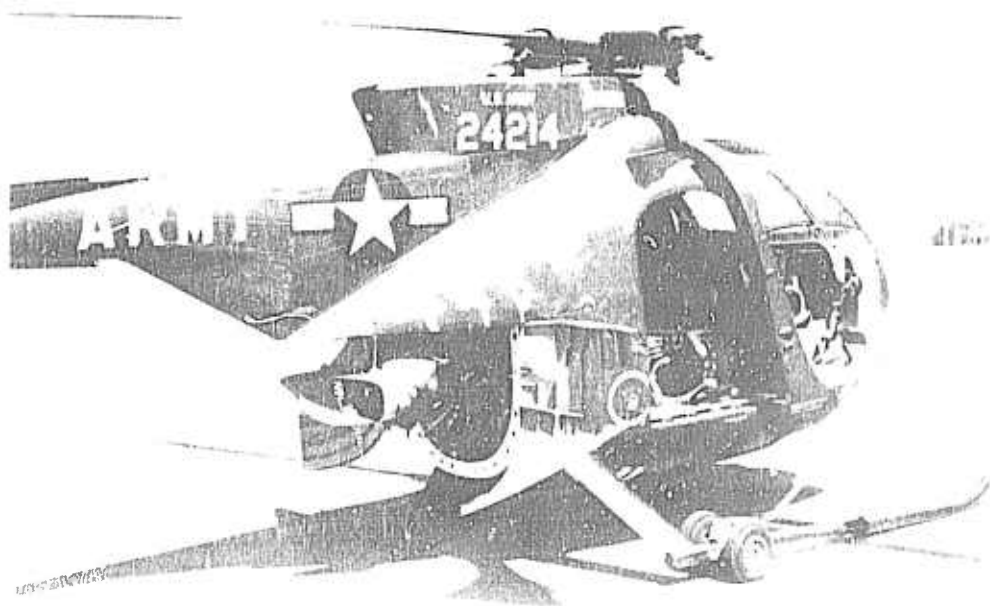
Figure 54. Completed Installation of Regenerative T63 in the YOH-6A.

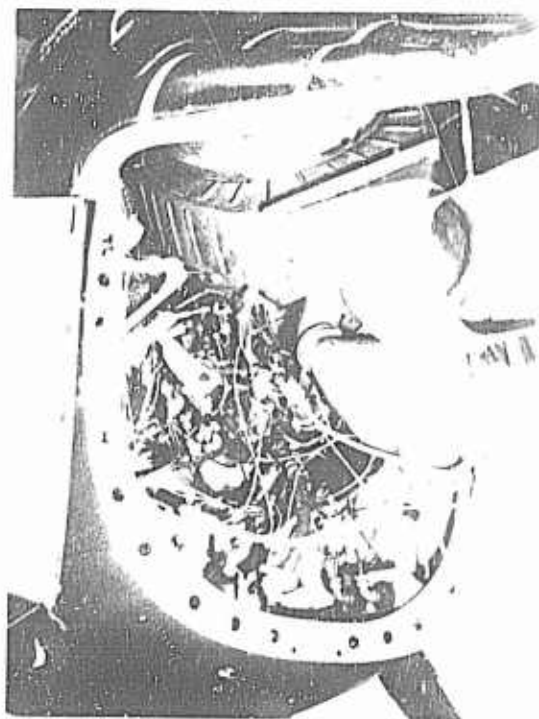
Figure 55. Completed Installation of Regenerative T63 in the YOII-6A.
